**CUE SHIRE HALL
DOWLEY STREET
SHIRE OF CUE
Tel 08 9963 1041
Fax 08 9963 1085**

Prepared by Alan Surgener
Consultant to **Measure Up! 2005**
Country Arts WA

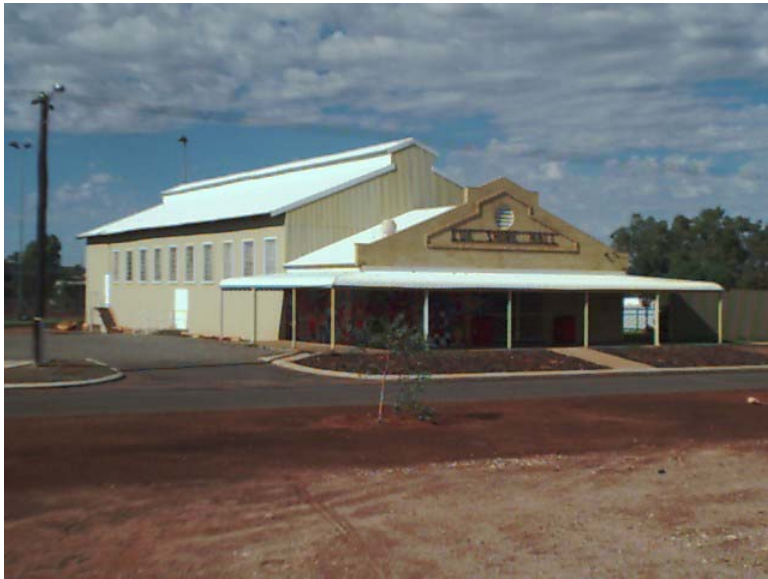
Built in 1991 and in good condition. A large rectangular auditorium with a flat ceiling and a 900-high raised stage. Estimated concert style capacity of 250, with an easy side load in access.

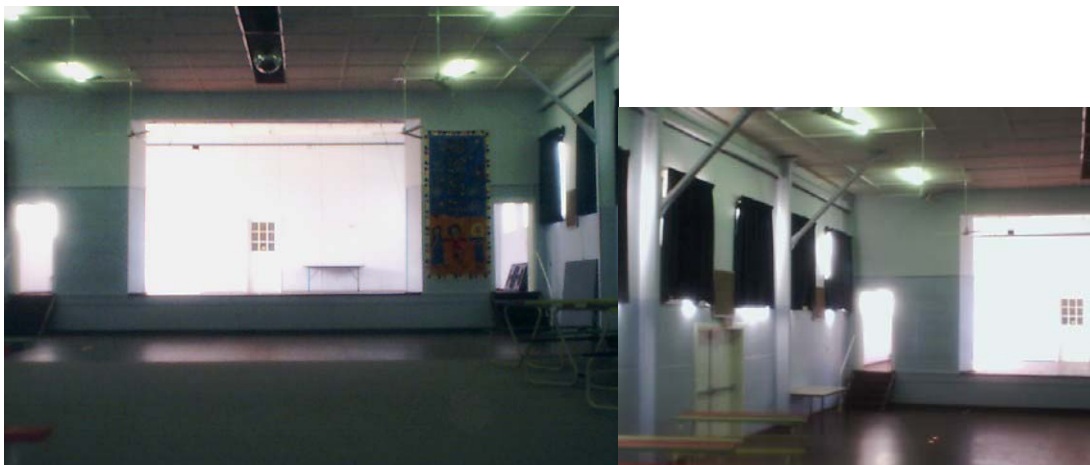
There is a 12300 wide and 8000 deep dance floor directly in front of the stage. *Note 4 x 4100 high ceiling fans above the dance floor just inside of the proscenium opening width.*
